FAILURE MECHANISMS THAT CAUSE HIGH ELECTRICAL LEAKAGE IN MULTILAYER CERAMIC CAPACITORS

HIROFUMI IKEO, SANPEI SAKAMOTO, KEN SATO[†], HISAKAZU NISHIURA[†], and KATSUHIRO OHNO[‡]

Kita-Itami Works, Mitsubishi Electric Corporation, Itami, Japan 664

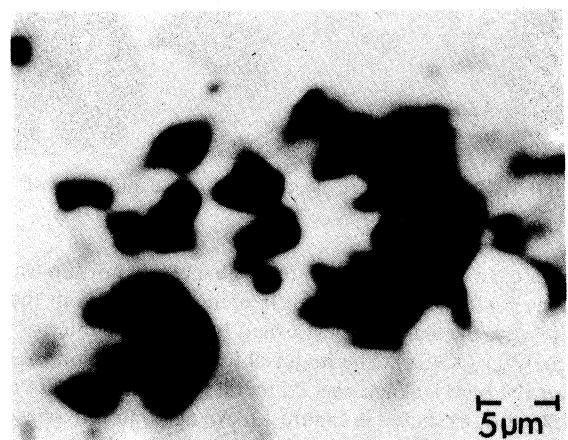
Third step: When the electron beam of a Scanning-Electron Microscope (SEM) is allowed to impinge on the insulator, a charging phenomenon occurs. However the charging phenomenon does not occur if the dielectric exhibits high leakage (see Figure 8). It is thus possible to determine the exact position of the high leakage portion of the dielectric exposed in step 2.

FIGURE 8 Charging image by SEM (insulation resistance of sample is 80 ohms).

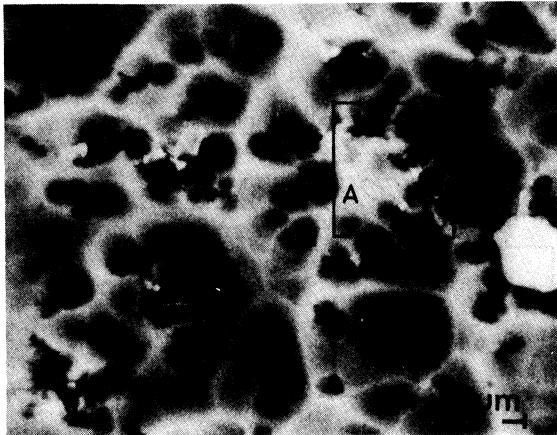
After charging, the ordinary secondary electron image of the SEM was used to study the structure of the high leakage portions as shown in Figures 9 and 10. The

FIGURE 9 Secondary electron image of Figure 8.

existence of small voids in the high leakage portion was thus confirmed. Subsequently element analysis in the vicinity of voids was performed by an X-ray micro analyzer (XMA). The material found to be responsible for the high leakage was Pd metal together with Cl^- in the voids as shown in Figure 11. An agglomerate phase containing Ca was also found near the voids. After bombarding the high leakage portion with Ar^+ ions step by step, it was also confirmed by SEM-XMA that

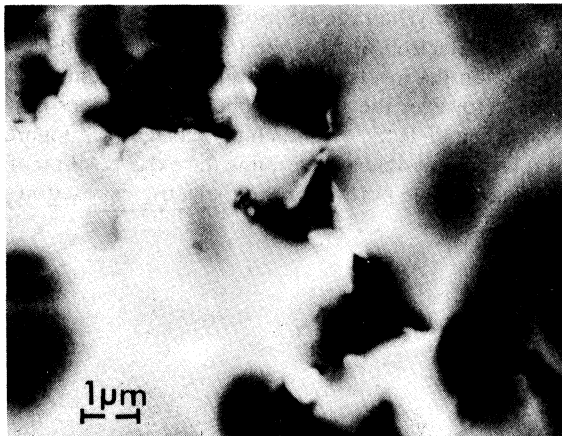
FIGURE 10 Secondary electron image (magnification of portion A in Figure 9).

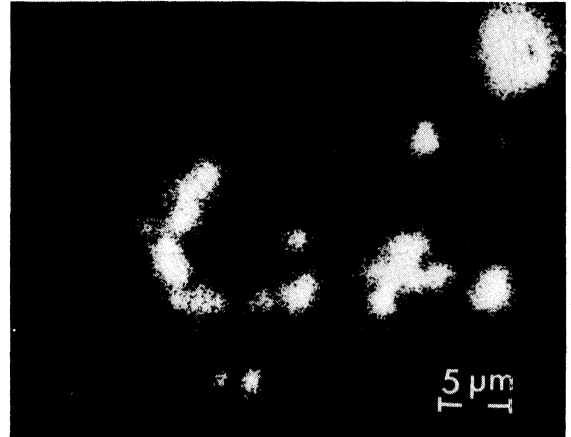
FIGURE 11 Characteristic Pd $L\alpha$ X-ray image.

the leakage path branched and penetrated more than one dielectric layer. The concentration of Cl^- ions together with Pd metal was found to be about 0.1 wt%. A failed capacitor having relatively high insulation resistance contained smaller quantities of Pd than failed capacitors having low insulation resistance.

It has been shown that the most important defects leading to the degradation of insulation resistance are small voids and microcracks leading from the outside of the capacitor through the inner electrodes. The causes of these defects are very complicated. It is suggested that the appearance of agglomerate phases in the ceramics, as found by XMA analysis must be avoided, since the difference in thermal expansion between the two phases may cause microcracking. Contamination

by Cl^- ions must also be eliminated because Pd dissolution at low dc voltage is increased in the presence of Cl^- ions.
