FAILURE MECHANISMS THAT CAUSE HIGH ELECTRICAL LEAKAGE IN MULTILAYER CERAMIC CAPACITORS

HIROFUMI IKEO, SANPEI SAKAMOTO, KEN SATO[†], HISAKAZU NISHIURA[†], and KATSUHIRO OHNO[‡]

Kita-Itami Works, Mitsubishi Electric Corporation, Itami, Japan 664

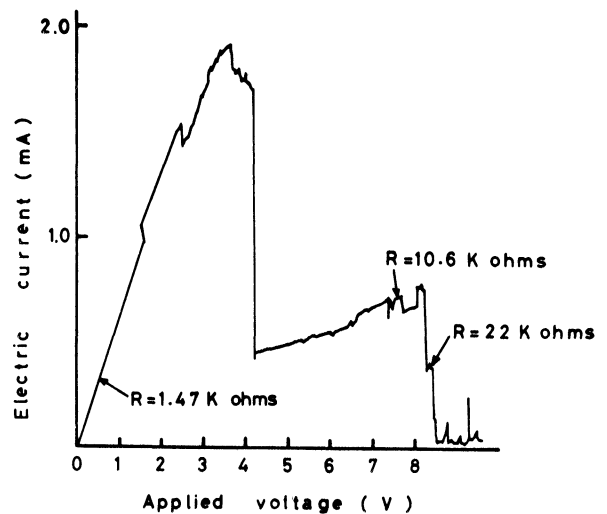
FIGURE 1 Voltage-current characteristic of failed capacitor.

1) Voltage-current characteristic at low voltages was ohmic as shown in Figure 1.

2) Most of the leaky capacitors recovered as the voltage was increased beyond several volts (they change discontinuously, with irreversible change, to the higher resistance level) as shown in Figure 1.

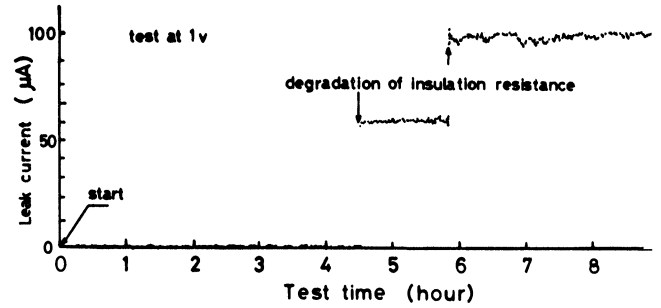
FIGURE 3 Abrupt degradation of insulation resistance at 1 V, at $+85^{\circ}\text{C}$ and in 85% RH.

Every capacitor was subjected to dc voltage stresses from 0.25 V to 10 V in an atmosphere of 85% RH and at $+85^{\circ}\text{C}$ in a thermo-hygrostat. Under voltage stresses, some of the capacitors failed at less than 10^4 ohms for applied voltage between 0.5 V and 3 V as shown in Figures 3 and 4. Acceptable capacitors after boiling did not fail at any voltage. The electrical properties of failed capacitors in this reappearance test were the same as those of the failed capacitors in the reliability test. This reappearance test method was evolved by taking account of the electrical properties and the environment of the failed capacitor.

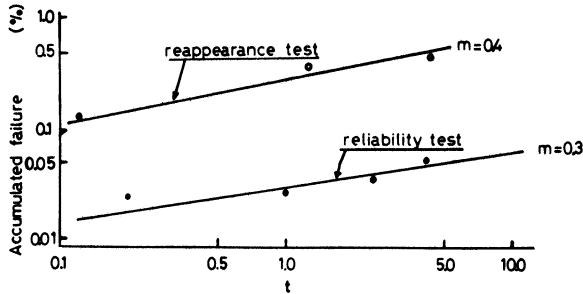
FIGURE 5 Weibull distribution analysis of failed capacitors.

Weibull distributions were plotted for the failed capacitors in two cases. The first was for the failures in the reappearance test, and the second was for the failures in the device reliability test. From Figure 5, the shape parameter m of the Weibull distribution can be seen to be 0.3 to 0.4 in both cases. It is therefore possible to detect failed capacitors because every failed capacitor belongs to a decreasing failure rate group.

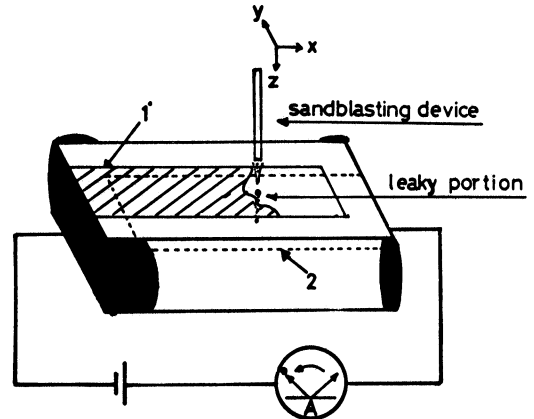
FIGURE 7 Procedure to clarify macroscopically leaky portion of capacitor.

little at a time, whilst watching the current across the dielectric, was performed until the observed resistance suddenly became infinite. This location, just before the resistance became infinite, is the macroscopic high leakage portion of the dielectric (as shown schematically in Figure 7).

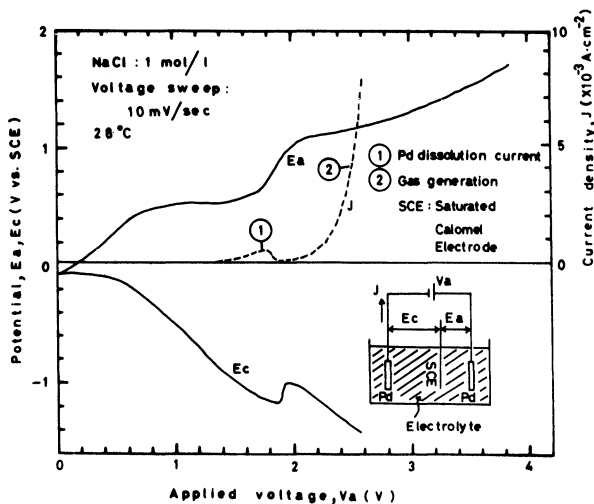
FIGURE 12 Electrochemical reaction test in an aqueous NaCl solution.

In order to study Pd migration, the dissolution of palladium was measured as a function of electrochemical electrode potential in water and in aqueous solutions of Na_2SO_4 , NaNO_3 , and NaCl . The relationships between the applied voltage V_a , the current density J , the anode potential E_a and the cathode potential E_c , are shown in Figure 12 for the case of aqueous NaCl solution. To measure the minimum dissolution voltage for Pd, the current (1) in Figure 12 is shown in Figure 13 on an enlarged scale. The beginning of the current increase appears around 0.3 V. This anode potential is equivalent to the applied voltage of about 0.5 V given in Figure 12.

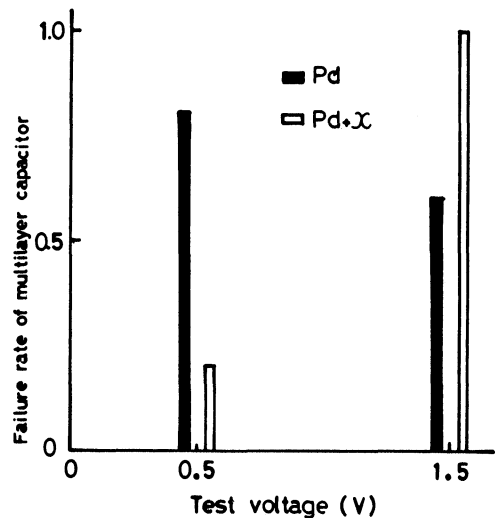
FIGURE 14 Dependence on test voltage of failure rate (for two cases: Pd inner electrode, Pd + x inner electrode).

groups: those associated with capacitors having electrodes of pure Pd metal and those associated with capacitors having electrodes in which the Pd is contaminated by a small amount of another unknown metal represented by x in Figure 14.

The fact that the failure rate of the Pd electrodes contaminated with small amounts of another metal is much higher at 1.5 V than 0.5 V is interpreted as showing that the voltage migration depends on the electrode material. Furthermore measurements of the time taken to arrive at failure gave figures of between one minute to 45 minutes for capacitors boiled in NaCl solution and 10 minutes to 10 hours for those boiled in water.

It can be seen that boiling in NaCl solution has an accelerating effect on the failure of insulation resistance in the capacitors.
